CWI Services Case Study: 002

Welding Quality Support for 40m Long Overhead Crane

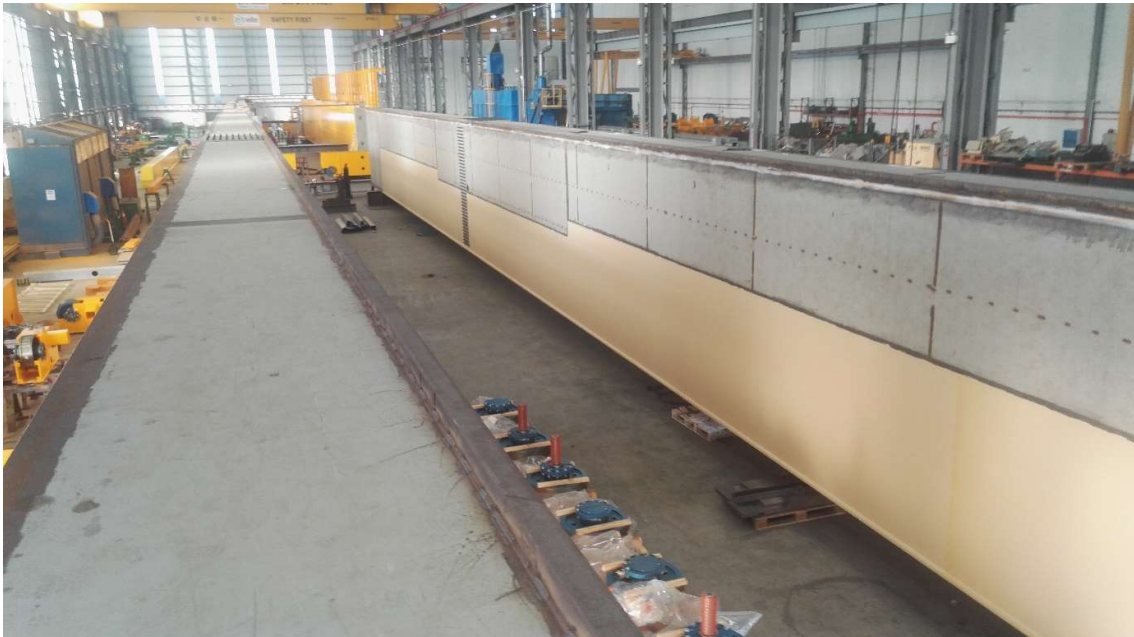
Figure 1 Girders for a unit of 40m overhead crane

MHE-Demag Malaysia (MDM) has recently completed two units of 40m long overhead cranes for a power plant in Thailand. The 40m long overhead cranes were the longest and widest overhead cranes manufactured by MDM. See Figure 1 for the girder of the 40m overhead cranes.

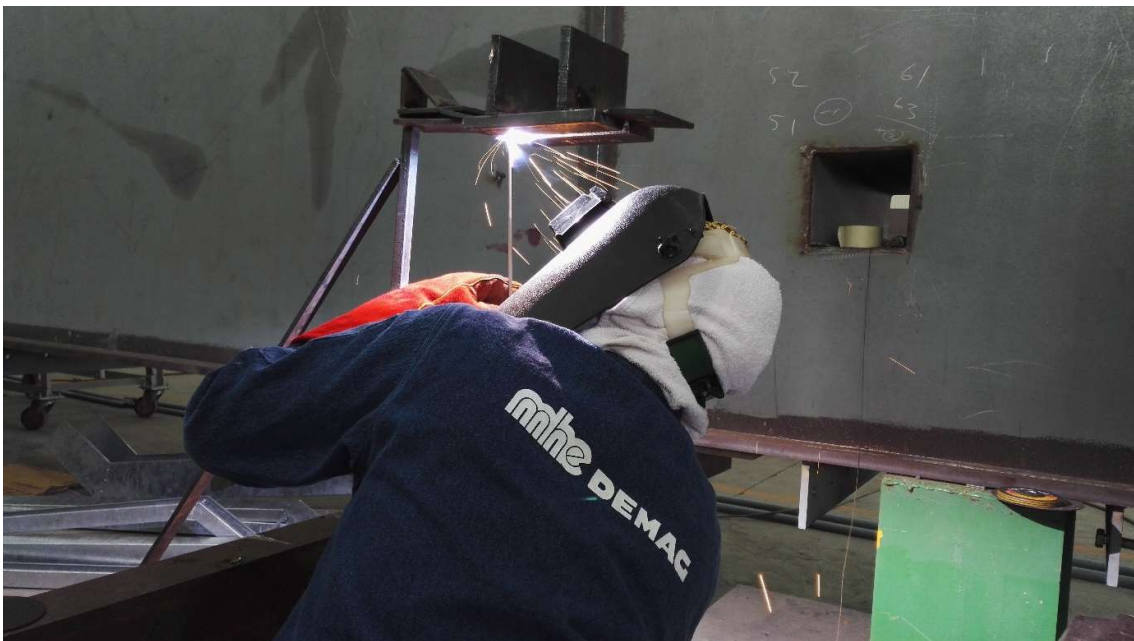
Figure 2 Welding of welding procedure qualification test specimen at the 4G welding position

CWI Services provided a Certified International Welding Engineer (CertiWE) to perform the welding and welder qualification services for MDM. The CertiWE of CWI Services developed an all positions welding procedure specification (WPS) for FCAW process. The WPS was developed in accordance with the requirements of AWS D1.1, See Figure 2 for welding of procedure qualification test specimen.

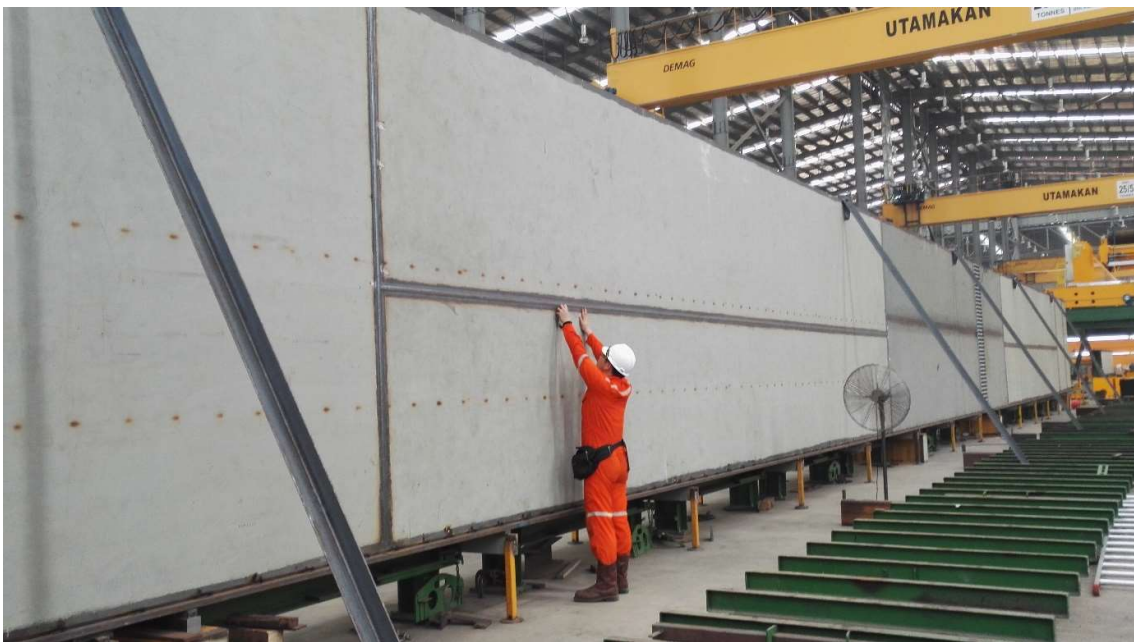
Figure 4 Visual inspection of butt weld of a 40m long girder

For the visual inspection service, CWI Services provided a CSWIP certified senior welding inspector to carry out 100% visual inspection of all the weld joints of the overhead cranes. The CWI Services welding inspector carried out visual inspection in accordance with the requirements of AWS D14.1. See Figure 4 for visual inspection activities. During the inspection support, the welding inspector of CWI Services also provide welding defects rectification method to MDM. In order to manage the inspection record and results, the welding inspector of CWI Services developed a customised and comprehensive weld ID system and inspection report template to record the visual inspection results and information related to the inspected weld joints.
